Inspection Report

1234 Any Street
Allentown Pa

A2Z Inspection Services

Date: 3/26/2009	Time: 12:30 PM	Report ID: 4312-Sgcom
Property: 1234 Any Street Allentown Pa	Customer: Mr. Sample PCA	Real Estate Professional: Agent One abc Realtors

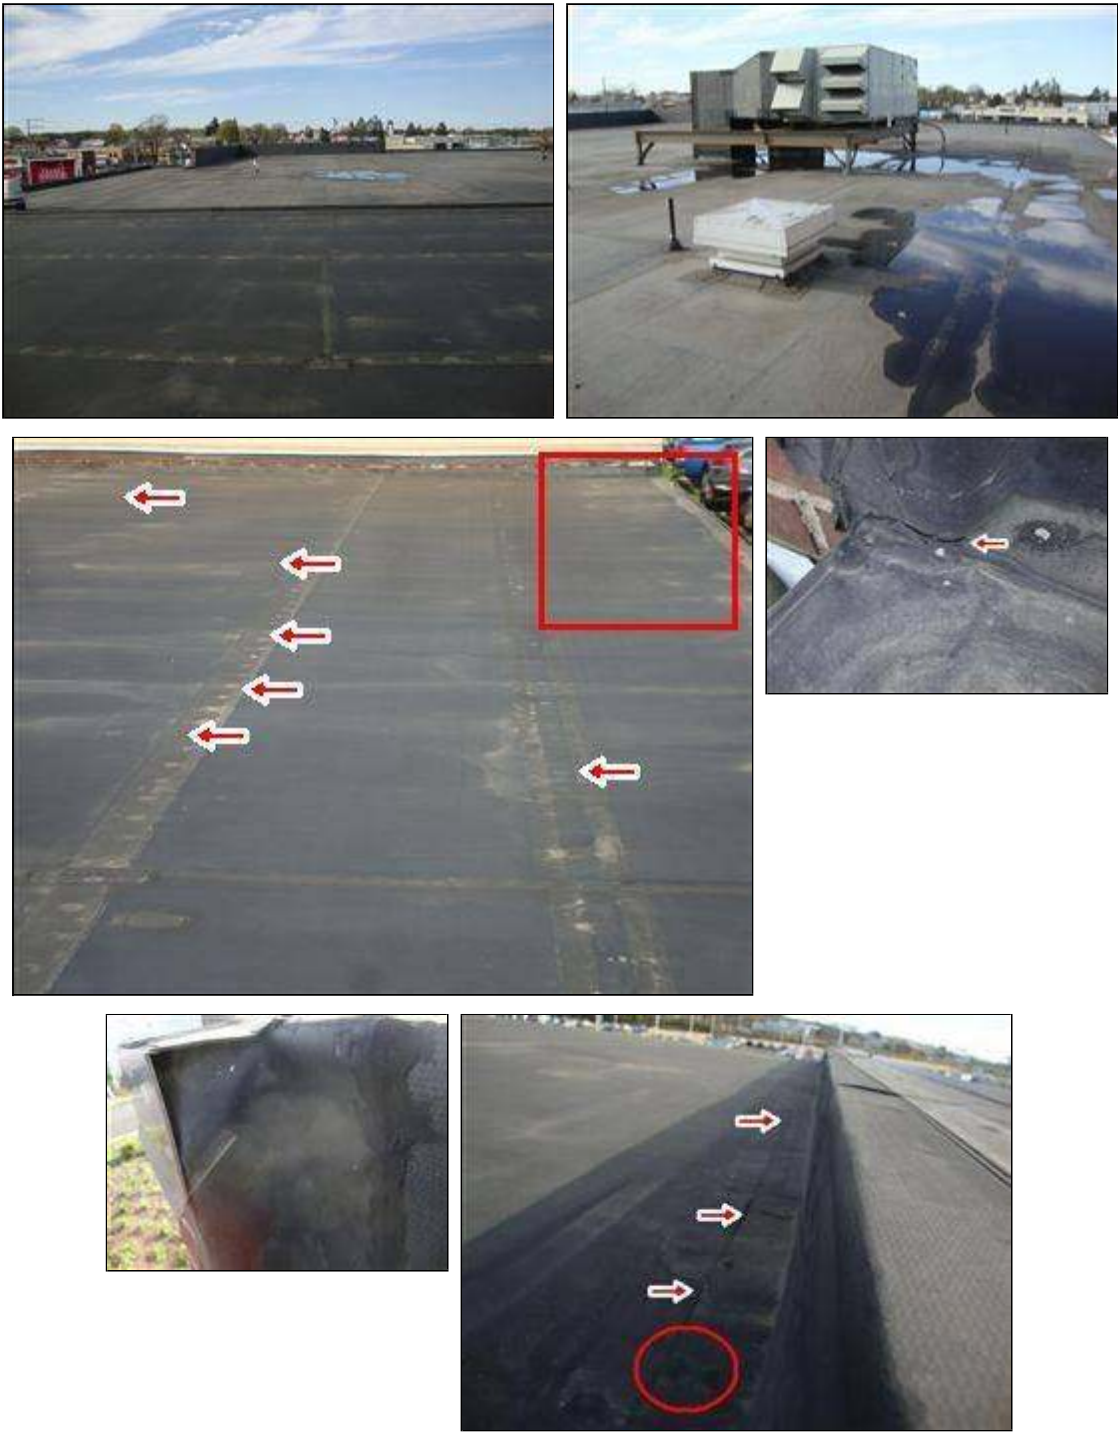
.045 EPDM roof covering.

Evidence of past and current ponding on roof surface, insulation lifting off concrete deck - possible cause moisture under the roof covering dissolving the glue that holds the insulation to the deck. Recommend non invasive infrared thermal imaging of the roof to determine the extent of water intrusion and possible damage.

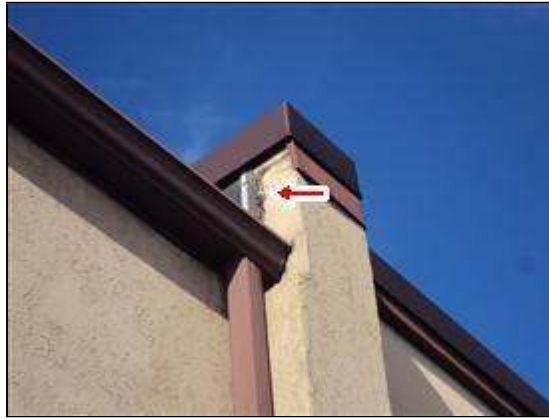
(2) Sealant deteriorated at parapet wall - moisture intrusion point. The use of sealants is a temporary solution to help prevent water intrusion. A roofing contractor should be consulted for a price quote to replace the flashing and provide a more permanent repair.

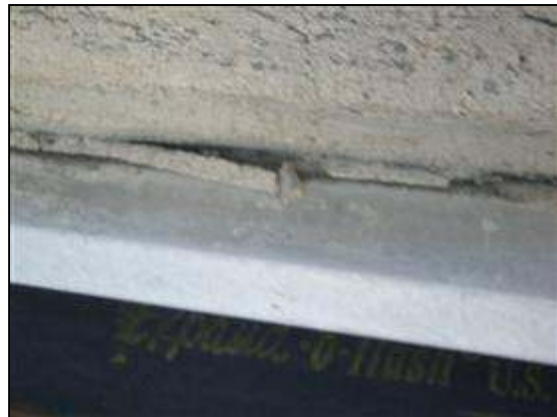
(3) Roof flashing is deteriorated in numerous areas - moisture intrusion points.

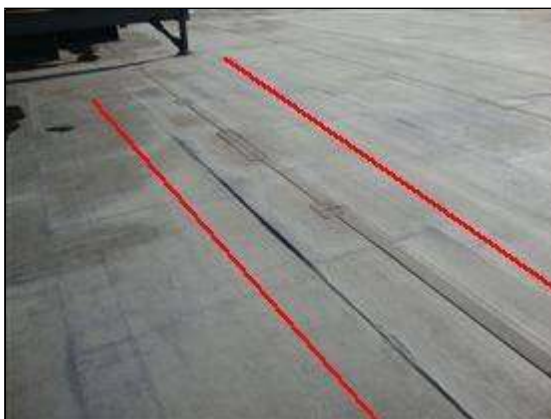
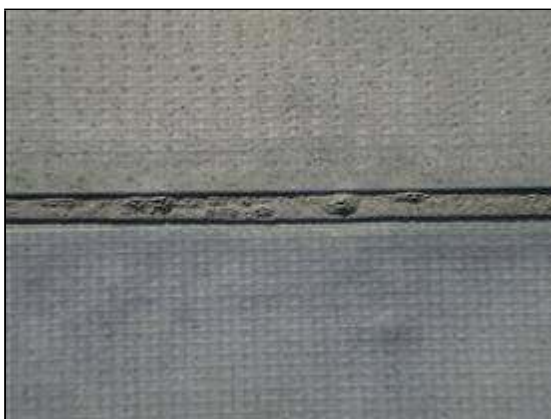
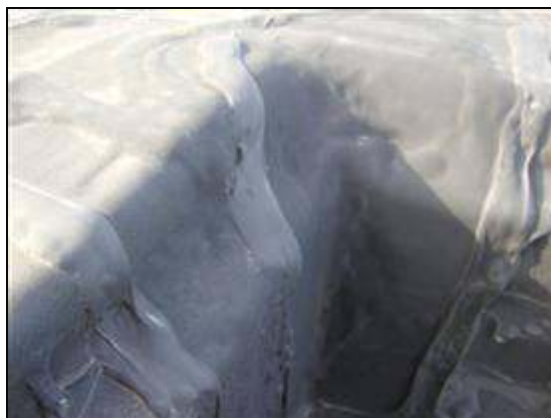
(4) Foam board insulation lifting, seams and cap flashing deteriorated at multiple areas of the upper and lower roofs.

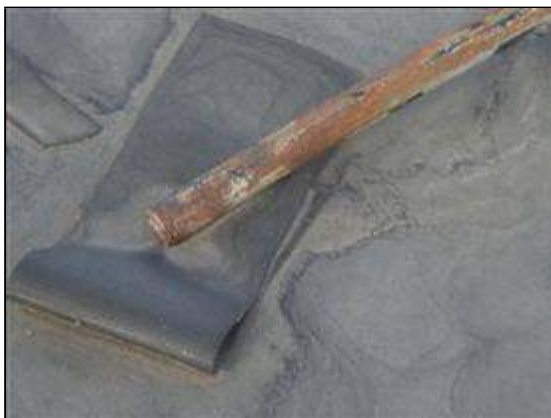
- 🏠 (5) Abandoned pipe laying on roof - recommend removal to help prevent it from puncturing the roof covering.

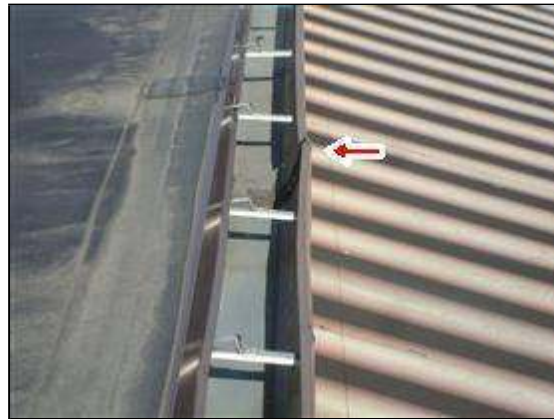
(1) Gutters have split seams and missing leaders at numerous locations.

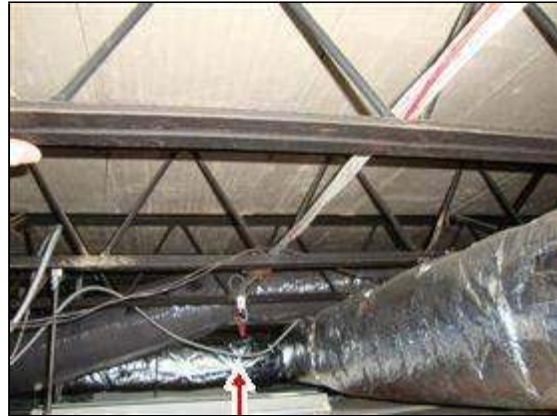
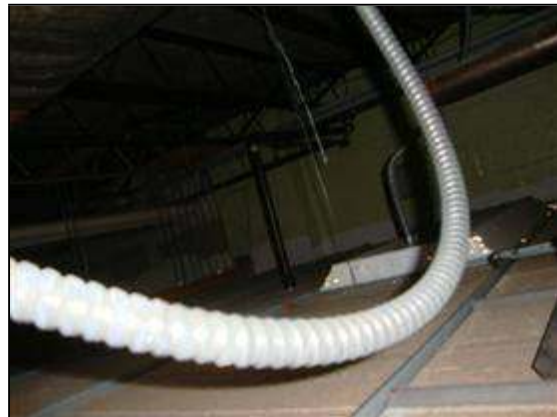
(1) The electrical wiring in attic was not secured to wood members properly, and was not installed neatly or in 90 degree turns as in standard workmanlike practice. This may indicate that a licensed electrician did not perform the work or did not follow standards (for your information).

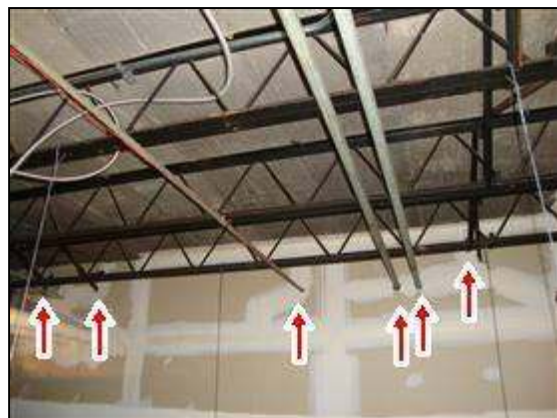
(2) Through the wall penetrations are not consistent with current standards for a proper fire wall (double 5/8" sheetrock and fire resistant sealant at all penetrations). Recommend adding fire resistant sealant as a safety upgrade.

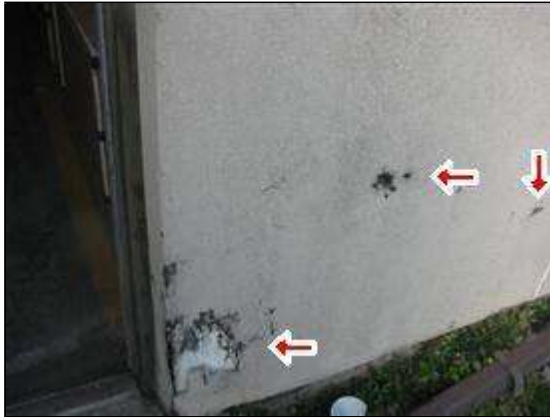
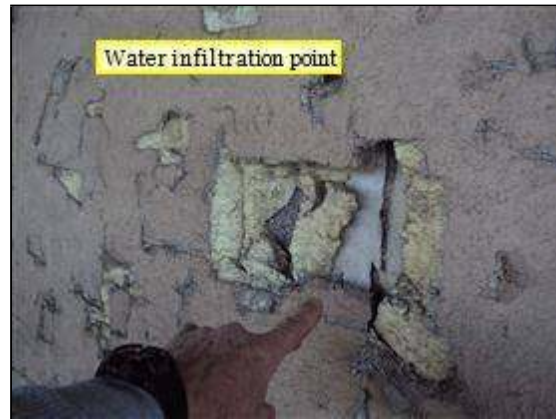
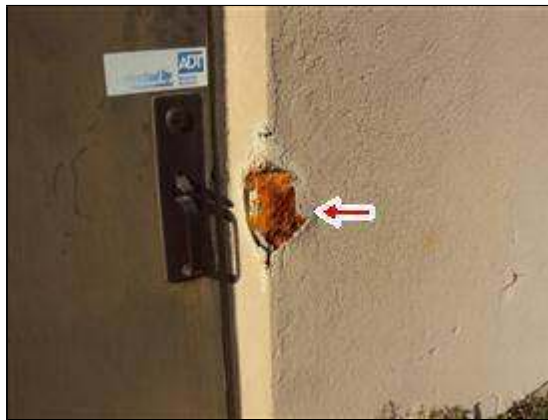
(1) Numerous areas of the stucco/EIFS finishing system over block have suffered damage to insulation and fabric membrane.

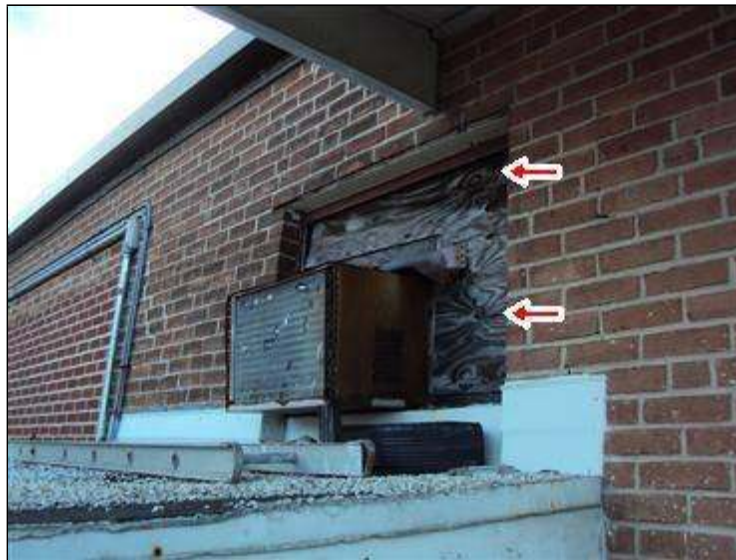
(2) Plywood exposed to the elements, no flashing installed. The plywood frame is delaminated and in need of repair.

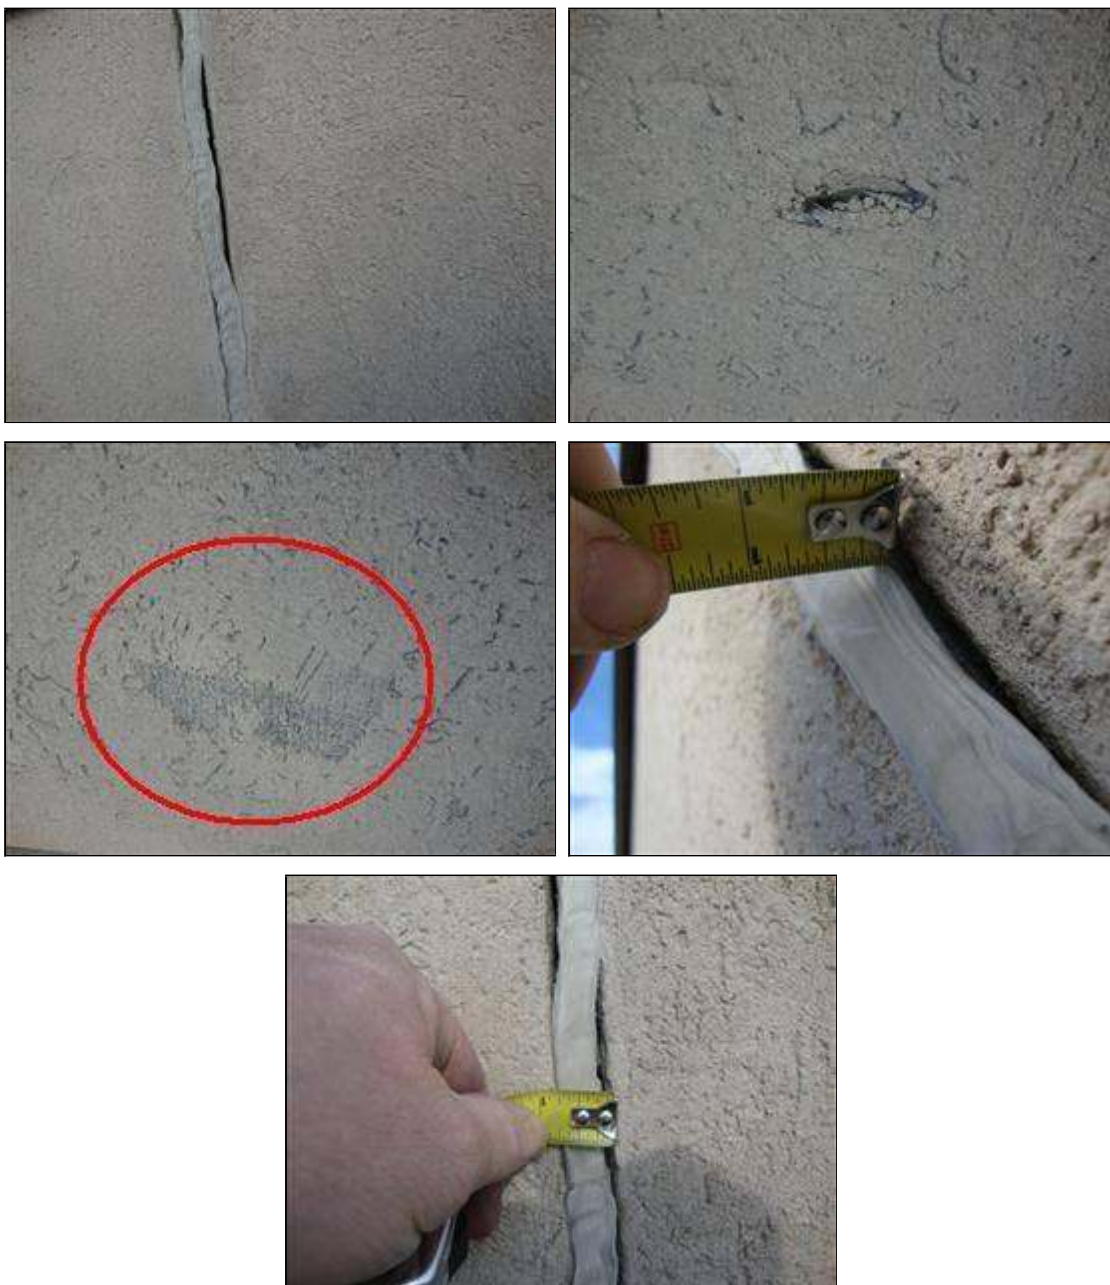
- (3) Wall separating lower roof from upper roof in need of repair.

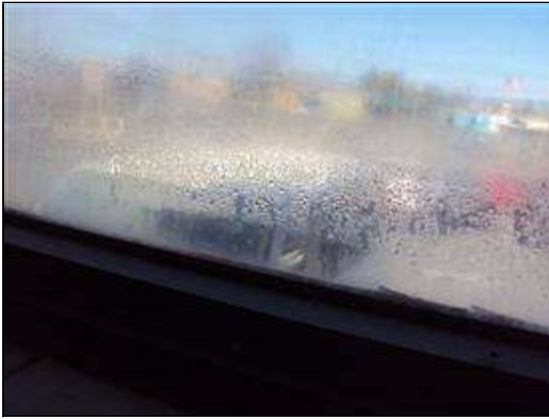
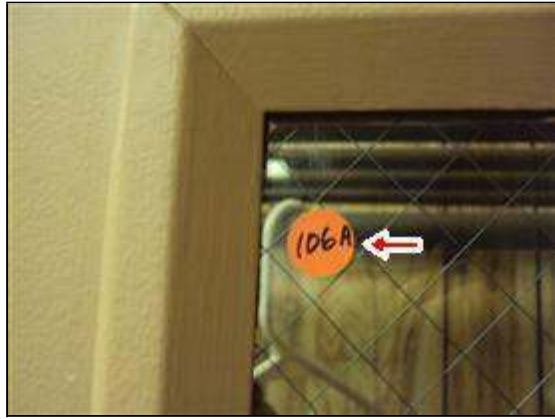
(1) Room 106 - Office area off main lobby - bad seal on exterior window - loss of thermal efficiency.

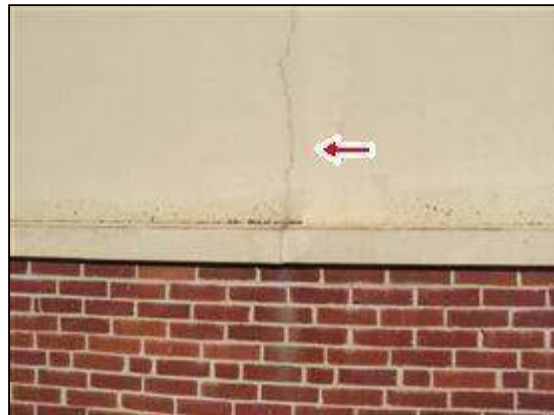
(2) Separation at wall joint, numerous exterior cracks, water infiltration point and potential structural issue when combined with the cracks and differential settlement noted at the interior of the exterior walls and piers. Further evaluation by a structural engineer is recommended.

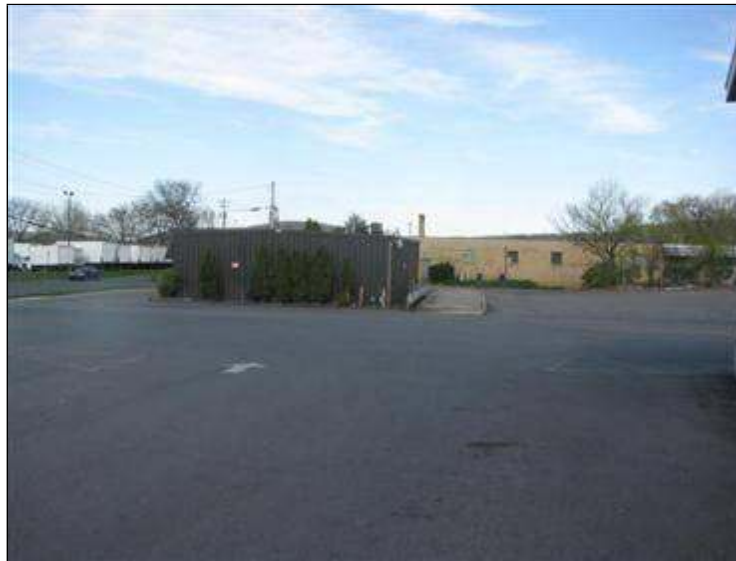
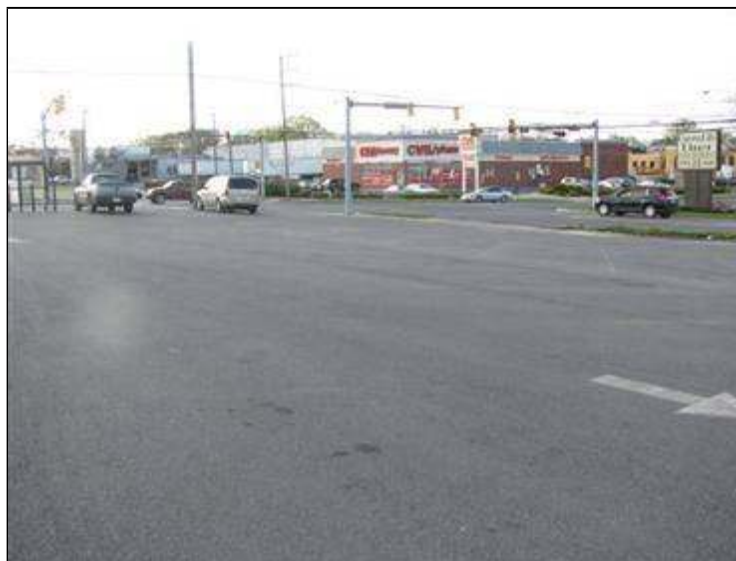
(2) Parking lot and driveway areas are in acceptable condition - minor repairs including seal coating is recommended to preserve the asphalt. It is recommended that the parking lot line painting be upgraded to conform with current fire codes as well as for handicapped accessibility.

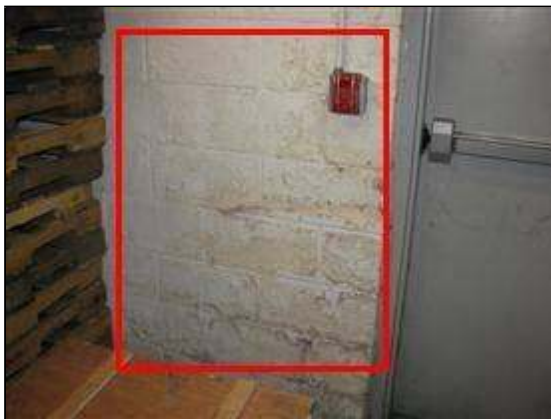
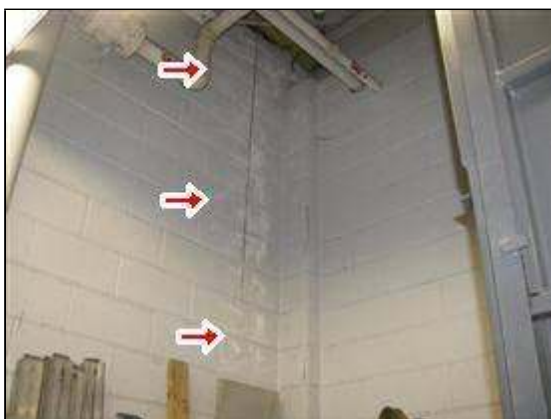
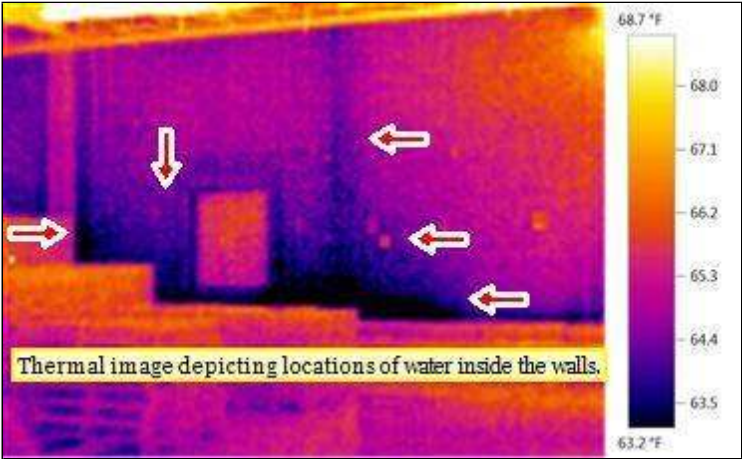
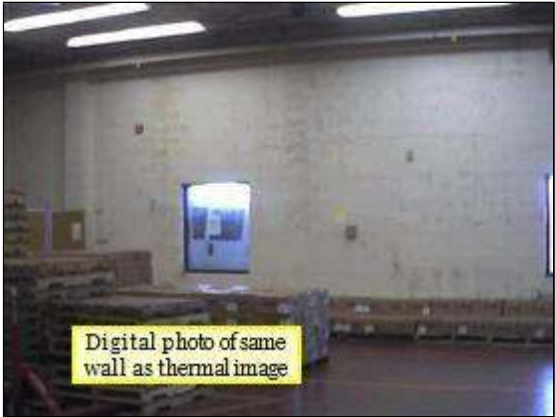
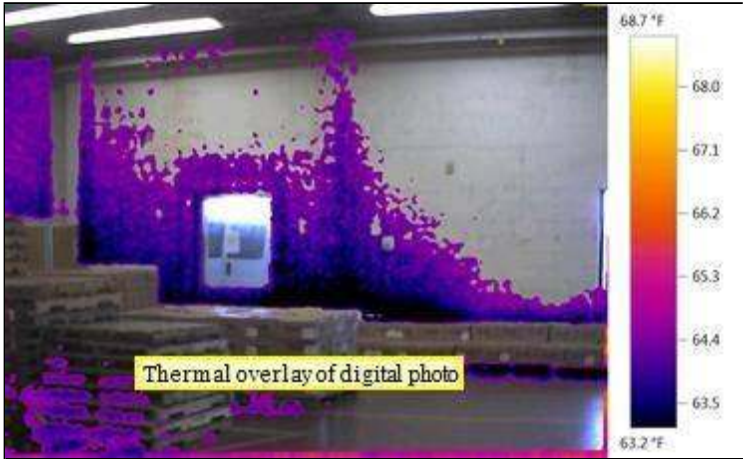
Efflorescence due to water infiltration through block, brick walls was noted along the north wall in warehouse & packing areas and along north wall of conference room north west office due to deteriorated gutter system and poor grading at the north east side of the building.

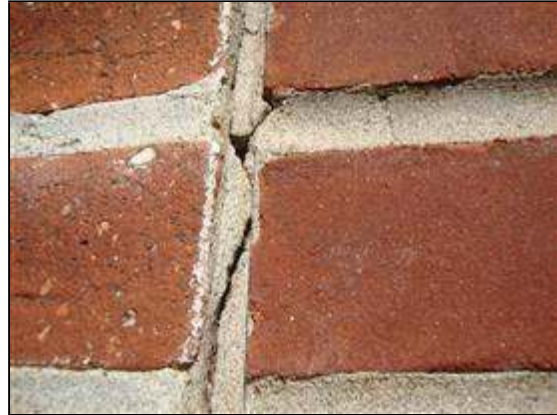
West exterior wall differential settlement, spalling noted. Improper grading allowing water to flow toward the building and undermine the foundation at the south west corner of the building. A landscaping professional, foundation contractor and or a mason should be consulted to improve grading and drainage as well as to make appropriate repairs.

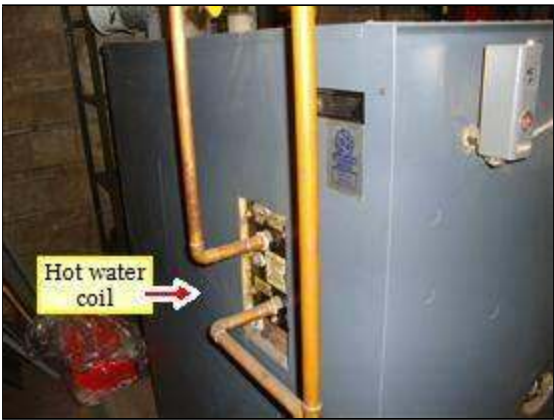
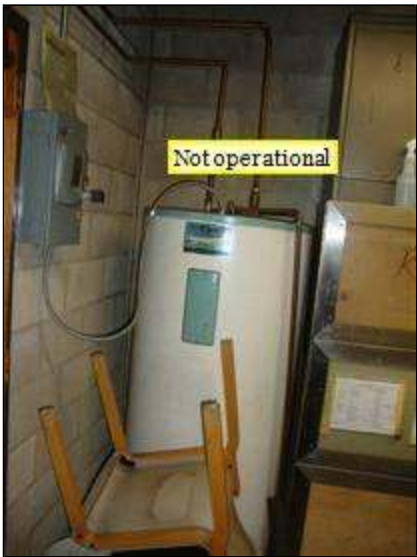
Old electric water heater was not operational - new hot water system working at all fixtures.

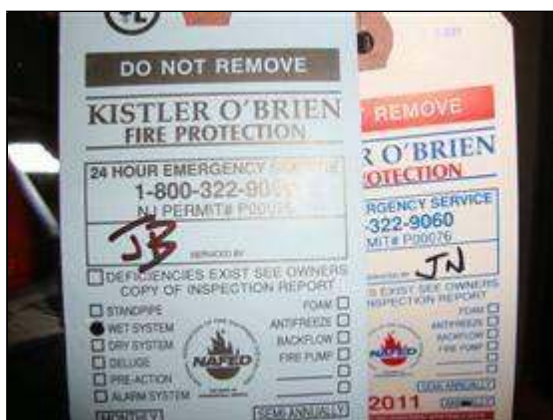
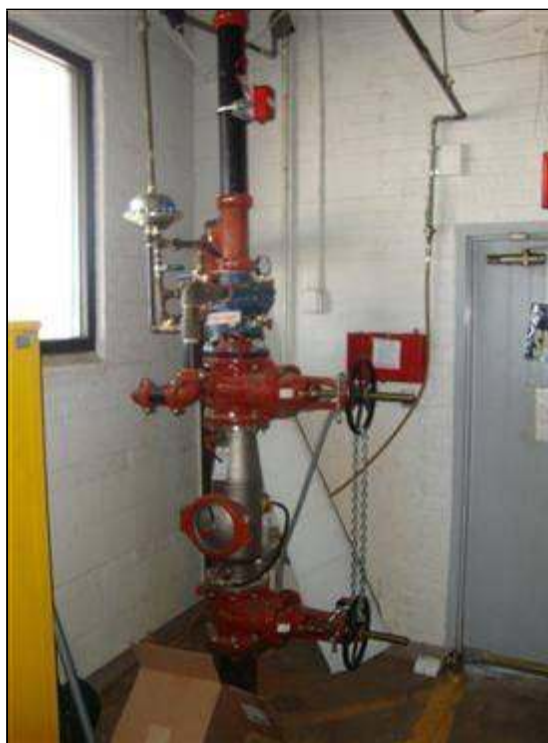
The fire suppression system is located in the machine shop, was last inspected in 2011 and appears to be in working order. This system is due for inspection annually - recommend having it serviced prior to closing.

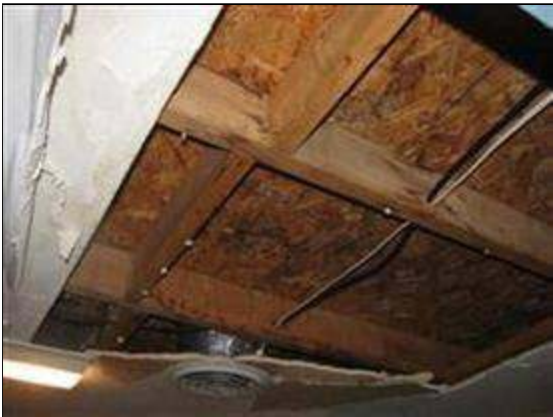
Area of ceiling affected by roof leak, sheetrock will need to be replaced, further inspection and repair to prevent future leaks.

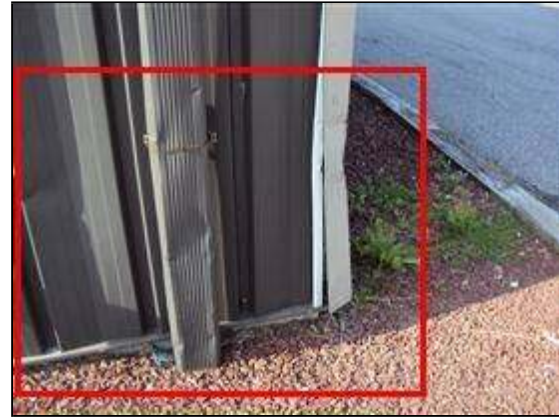
- (1) Minor cosmetic cracks, patches majority of rooms.
- (2) Damage to the exterior of the retail store.

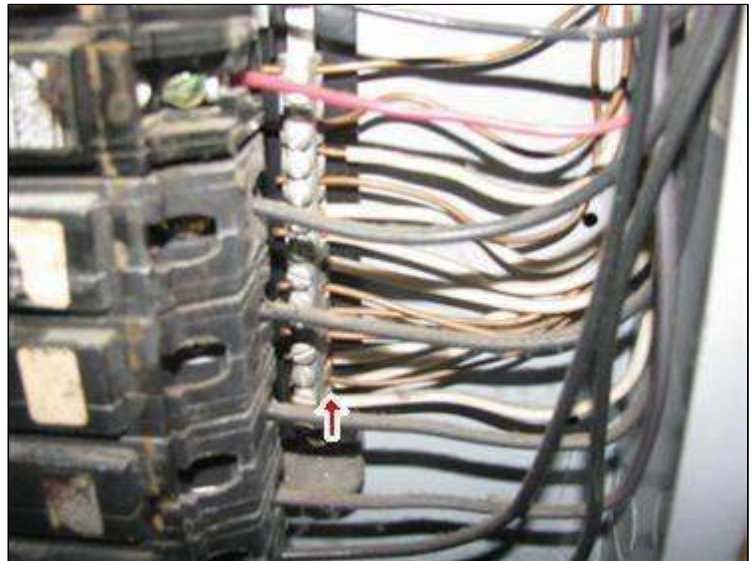
(2) Neutrals and grounds installed under the same lug - each neutral should be installed under a lug with no other grounds, neutral conductors nor conductors installed under the same lug. Repair by electrician is recommended.

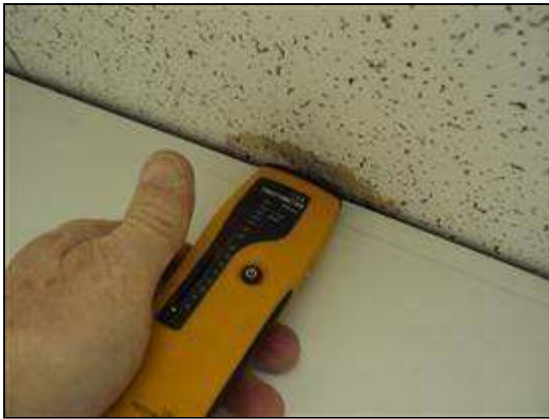
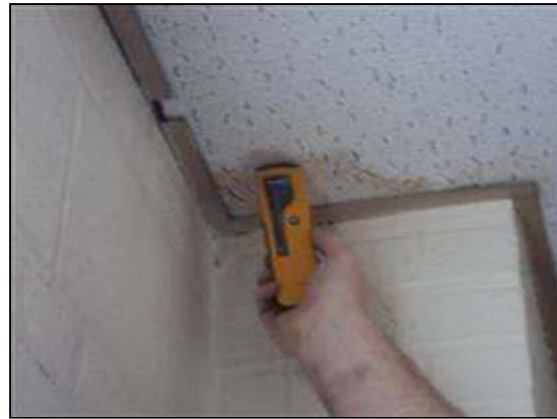
(2) Room 105 - Main entrance lobby at north west corner of building - water stained ceiling tile tested dry at time of inspection.

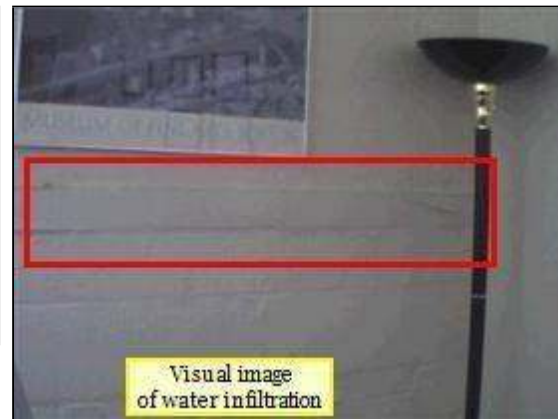
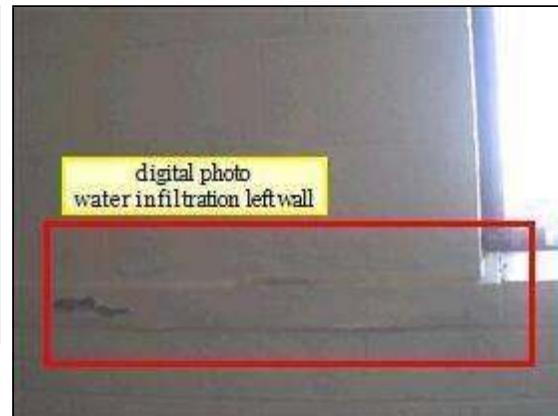
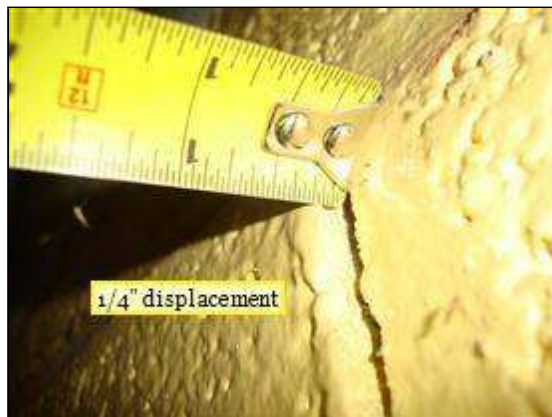
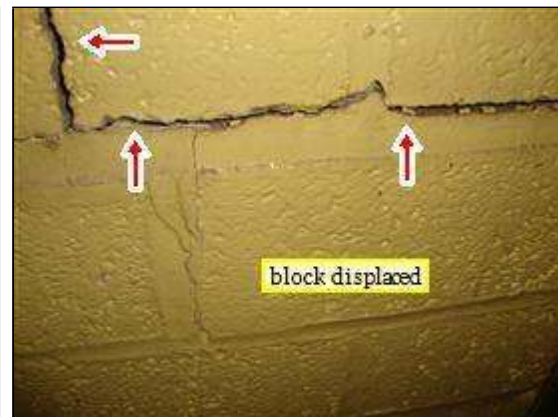
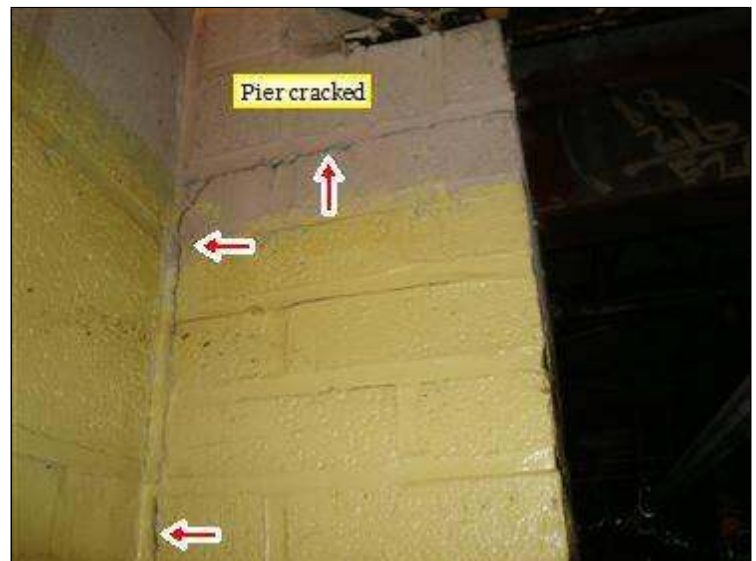
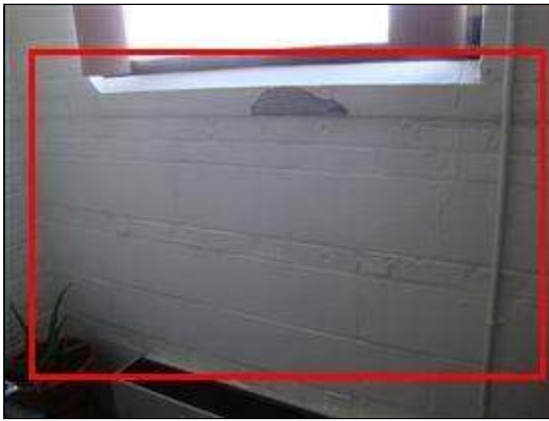
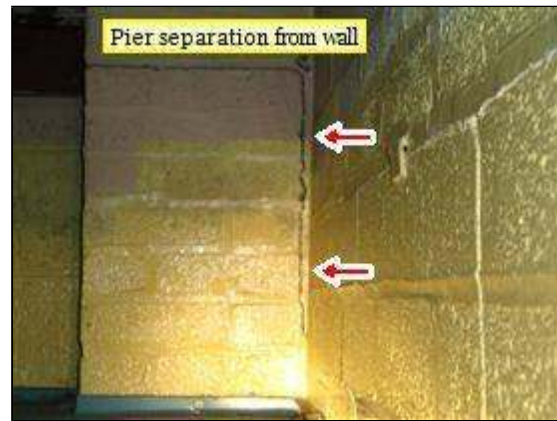
(1) Room 104A - North wall - West end of building - office area: Moisture intrusion from exterior block wall - paint delamination and rust from lintel over window. Right side of window has step cracks above ceiling with 1/4 inch differential settlement. Some degradation of concrete deck panels evident. The inspector utilized a Testo 881 thermal imager and Tramex moisture meter to confirm active water migration to the interior of the building.

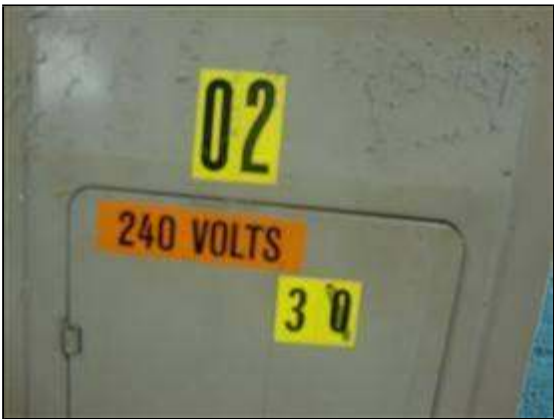
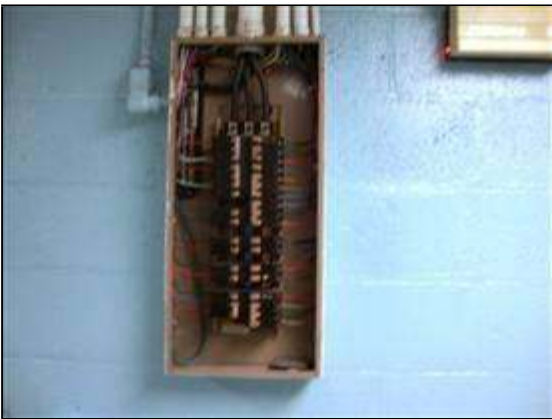
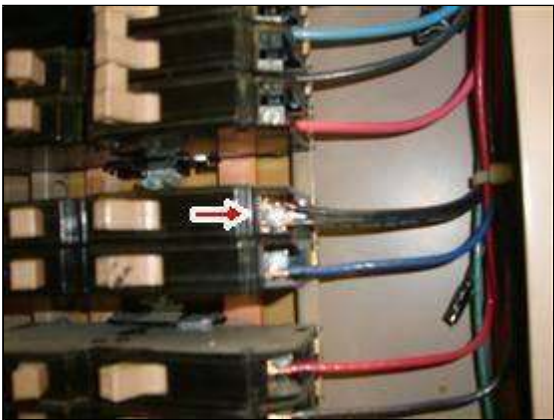
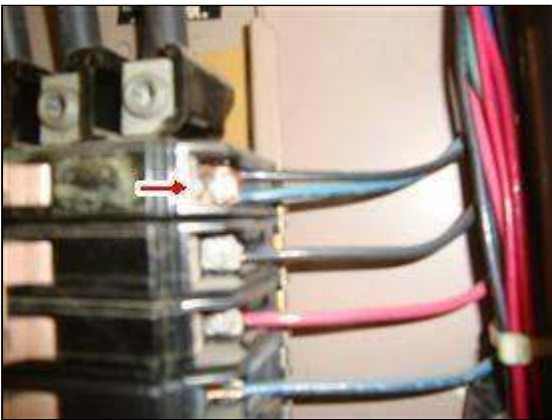
Electrical panel #2 - 240V three phase - double tap wires.

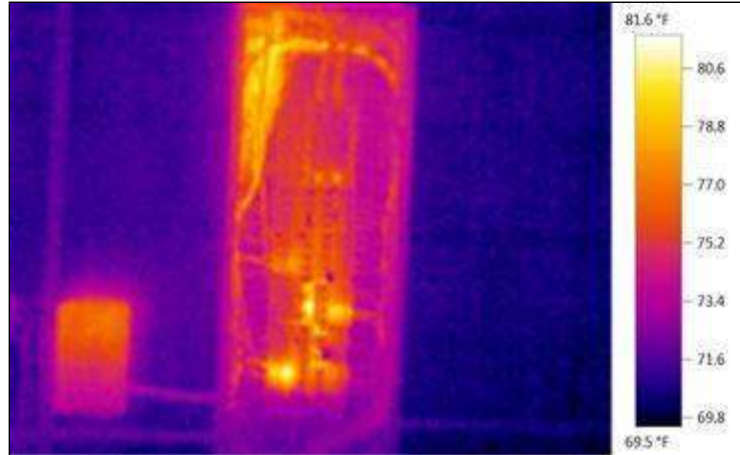
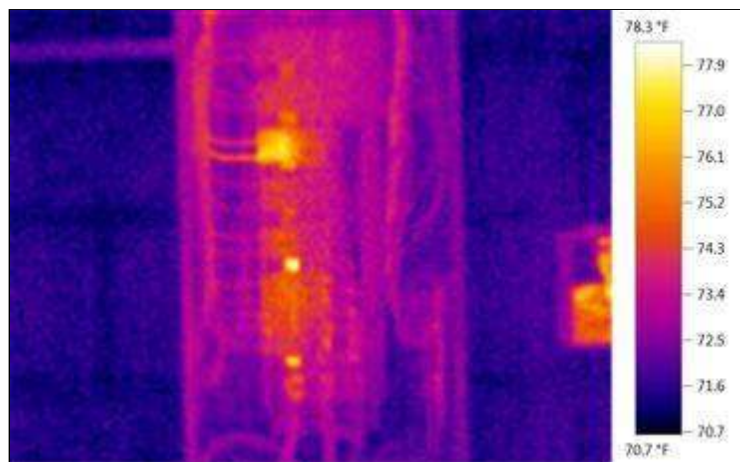
(1) Examples of qualitative thermal imaging scans of electrical panels in the facility. No thermal anomalies noted.

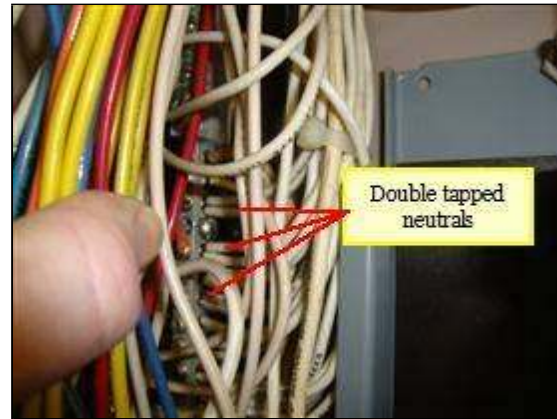
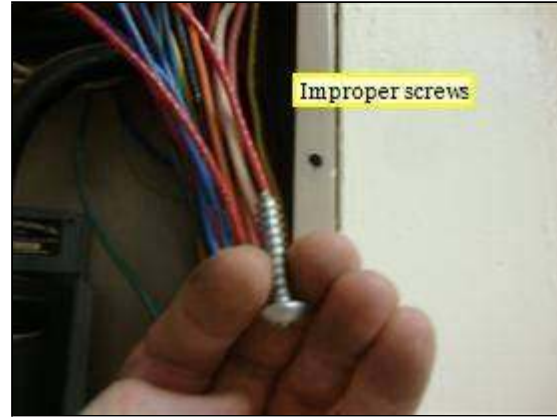
(2) Electrical panel #1 - 240V single phase - double tap neutrals wires.

Improper screw used to secure the panel cover (dead front).

The majority of the electrical panels have improper screws that need to be replaced with panel box cover screws that have blunt ends so they do not pierce the wires inside the box.

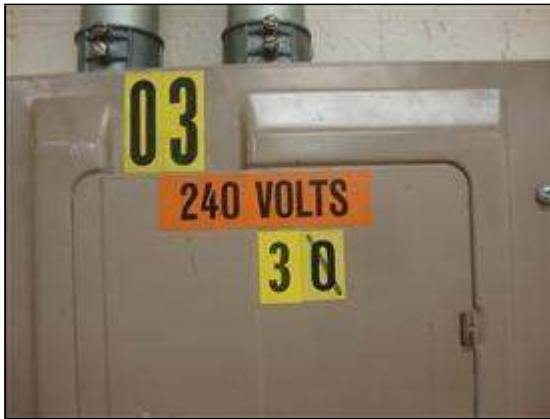
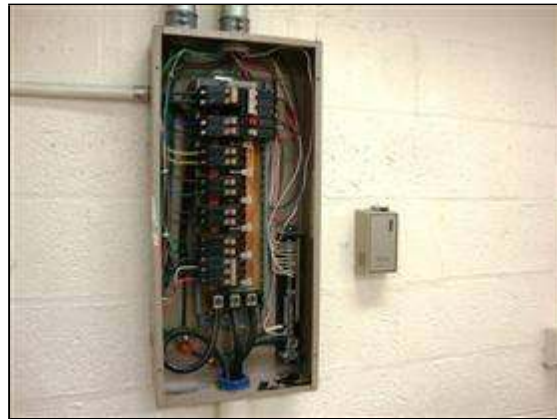
(4) Electrical panel #3 - 240V three phase - Improper sharp screws installed, screws are stripped and can not secure the panel cover.

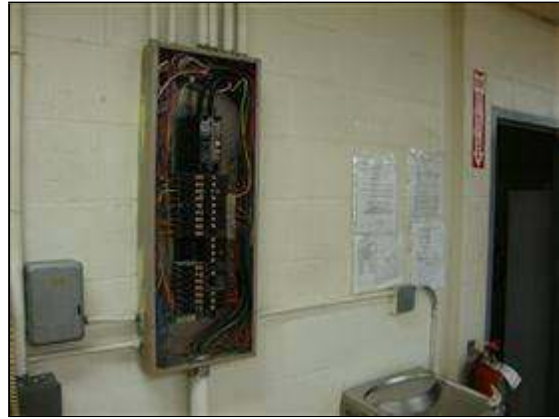
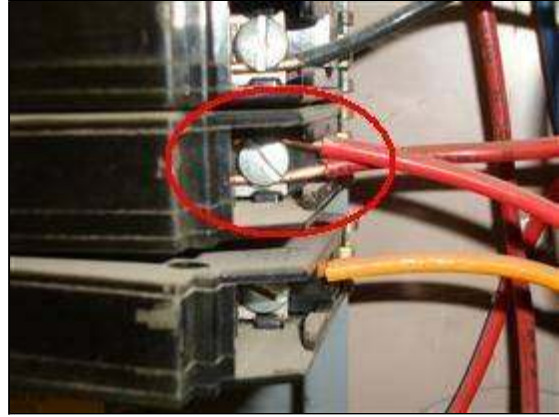
(9) Electrical panel #4 - 240V single phase - double tap wires.

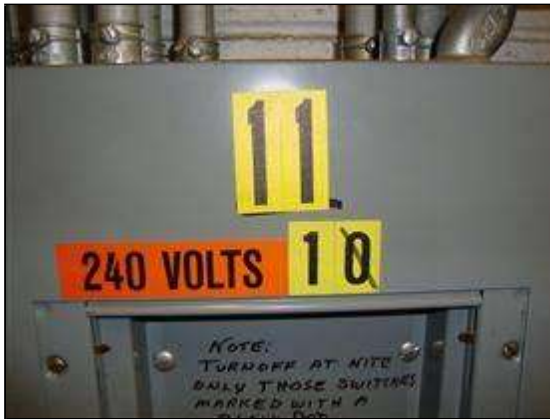
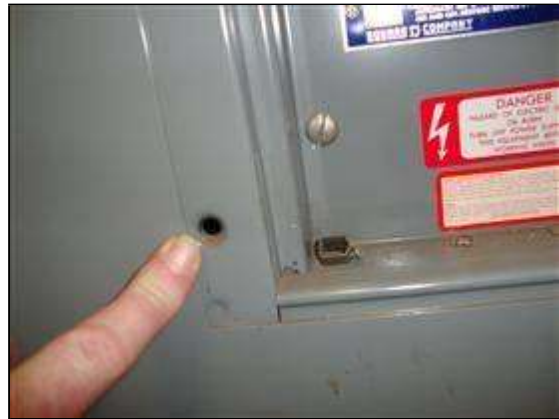
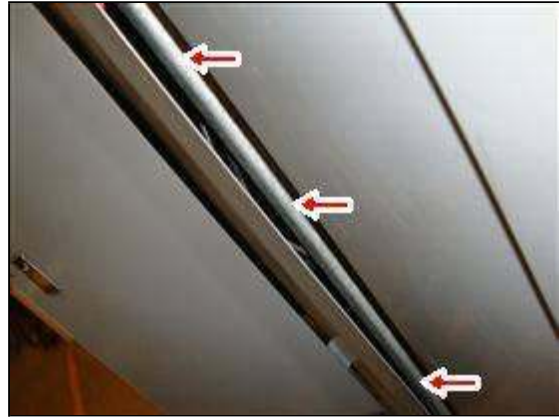
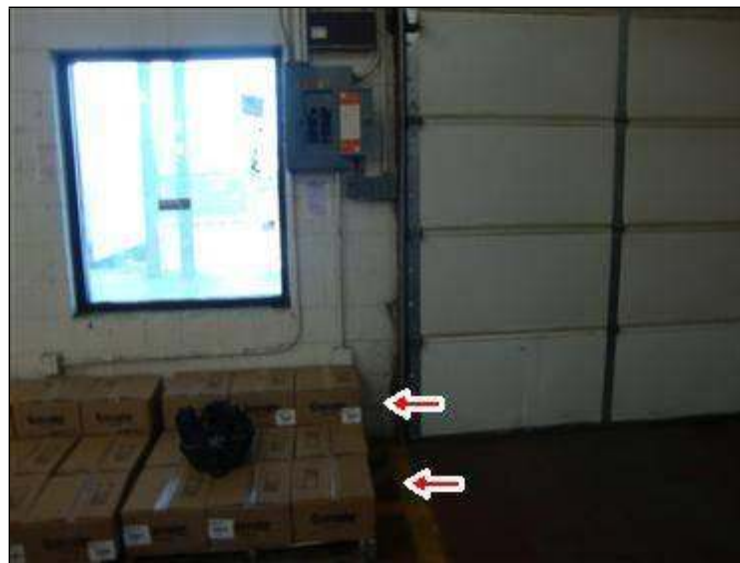
(10) Electrical panel #11 - 240V single phase - locked, missing screws, dead front not firmly affixed.

Electrical panel shipping area #2463 - Not inspected due to pallets of crayons stored in front of the panel.

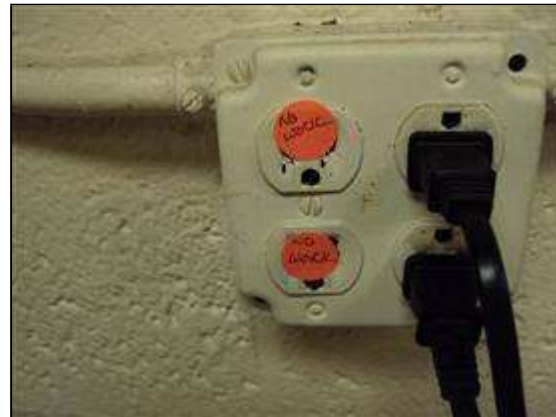
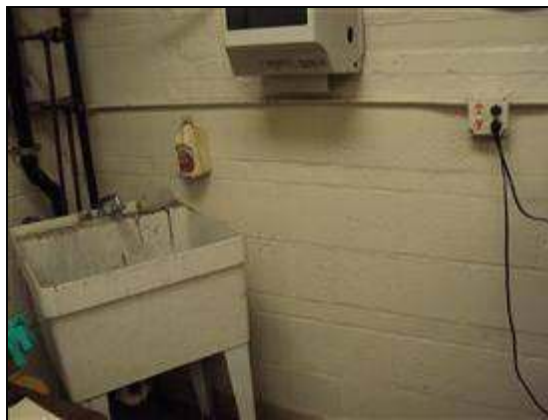
(2) 4x4 electrical junction box not firmly affixed to the structure.

Receptacles were not functional at the time of inspection.

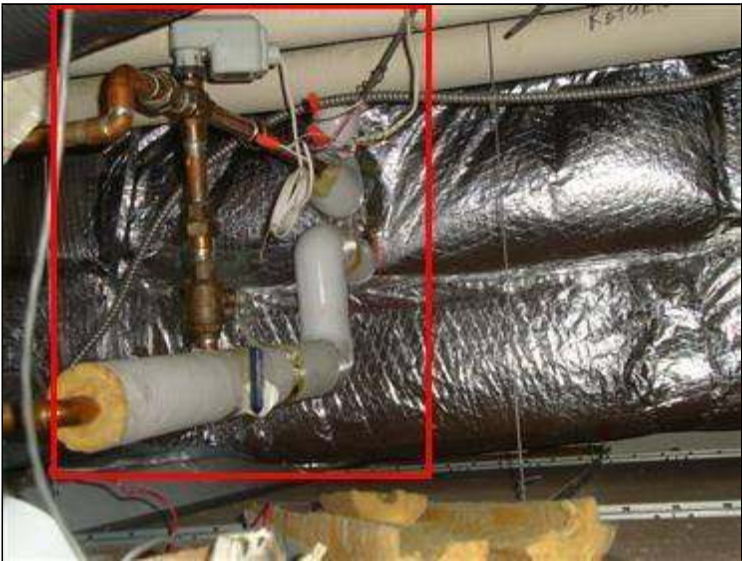
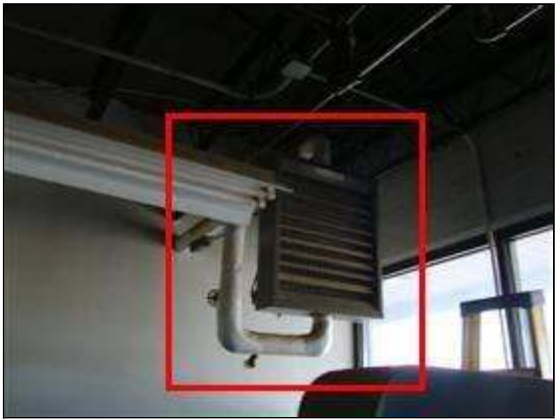
- (3) The offices are served with forced hot air by a boiler connected to a series of hot water coils installed inside the ductwork.

Digital photo depicts an example of hot water coils - no issues noted with this system.
