Inspection Report

1234 Any Street
Allentown Pa

A2Z Inspection Services

Date: 3/26/2009	Time: 12:30 PM	Report ID: 4312-Sgcom
Property: 1234 Any Street Allentown Pa	Customer: Mr. Sample PCA	Real Estate Professional: Agent One abc Realtors

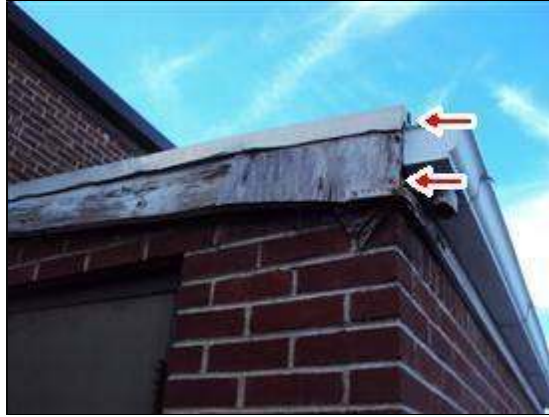
(1) Wood skirt at roof flashing is deteriorated and contributing to moisture wicking under the roof membrane.

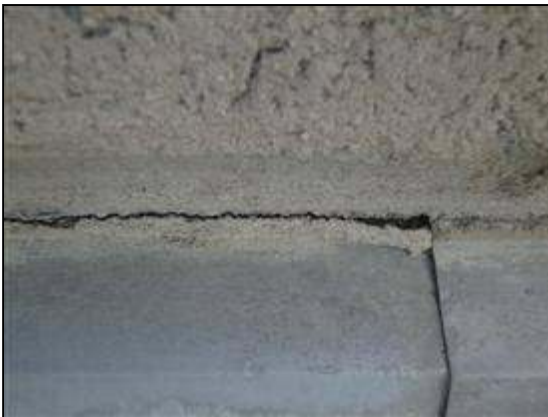
(3) Roof flashing is deteriorated in numerous areas - moisture intrusion points.

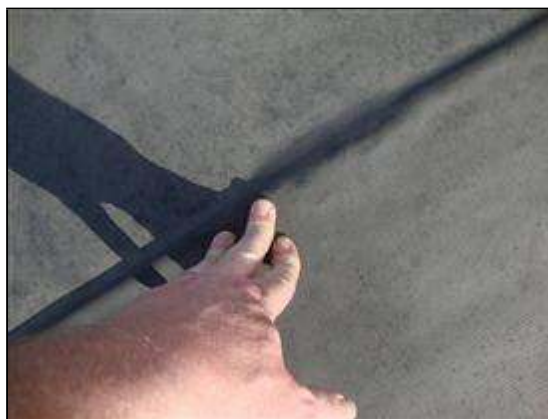
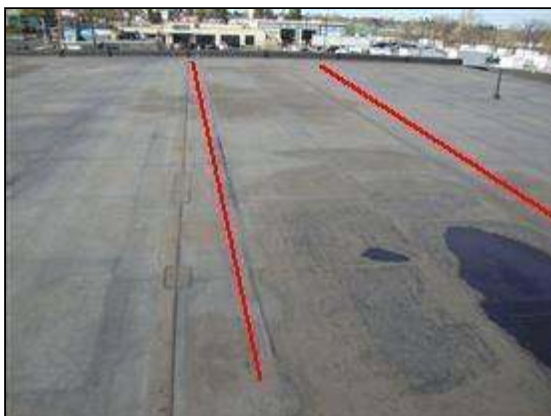
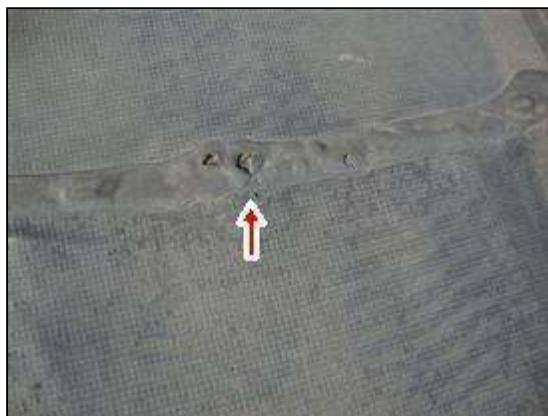
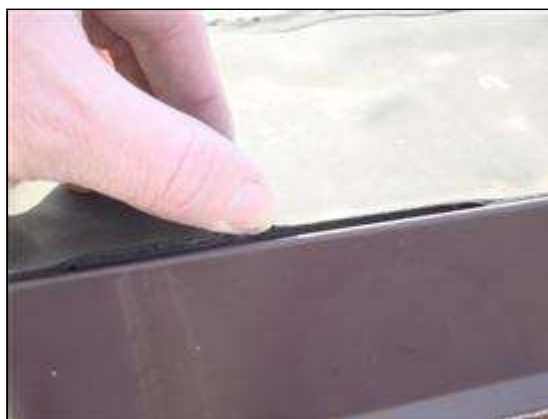
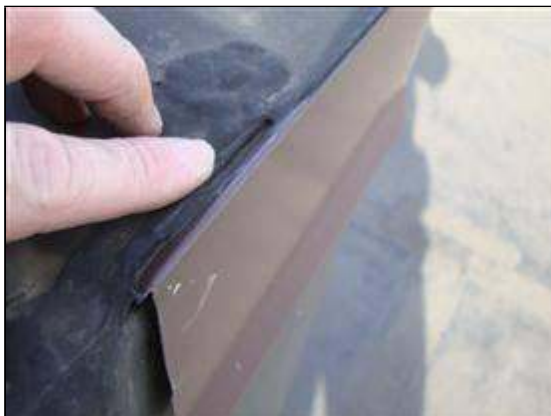
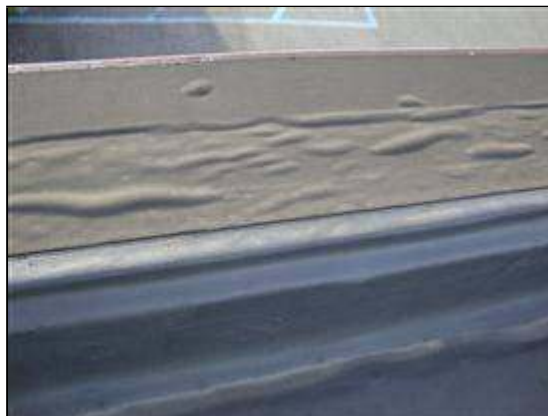
(4) Foam board insulation lifting, seams and cap flashing deteriorated at multiple areas of the upper and lower roofs.

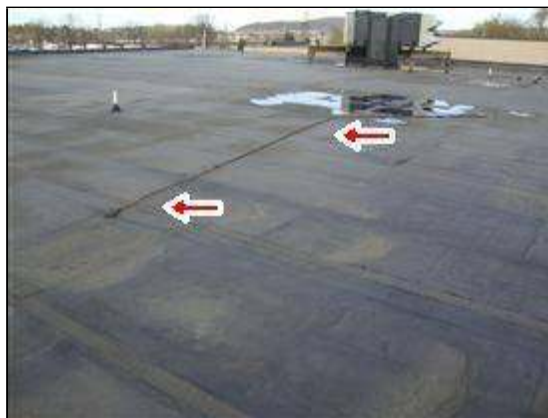
- 🏠 (5) Abandoned pipe laying on roof - recommend removal to help prevent it from puncturing the roof covering.

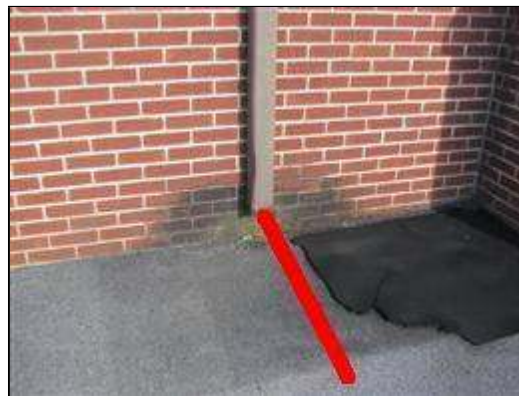
(2) Gutter leaders should extend a minimum of 6 feet from foundation to direct water away from the foundation.

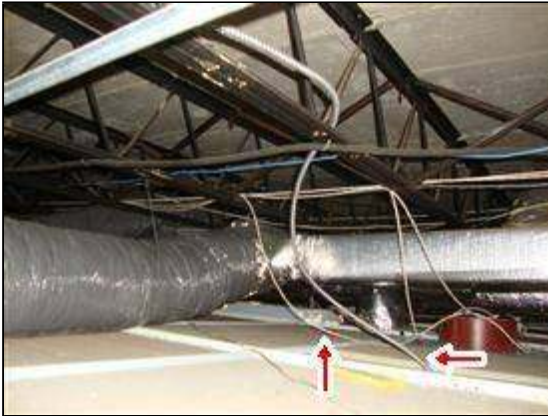
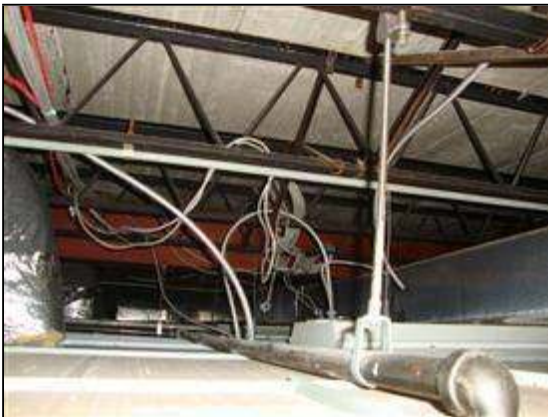
(1) The electrical wiring in attic was not secured to wood members properly, and was not installed neatly or in 90 degree turns as in standard workmanlike practice. This may indicate that a licensed electrician did not perform the work or did not follow standards (for your information).

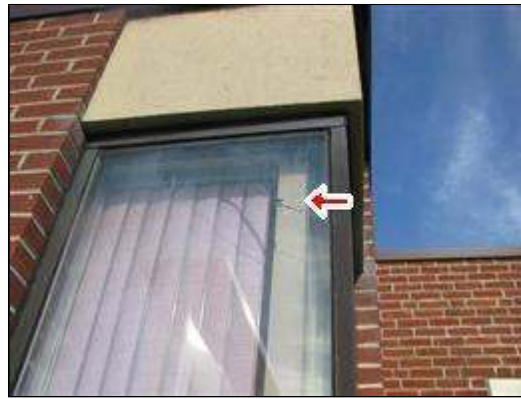
(2) Cracked window located at west side of the building.

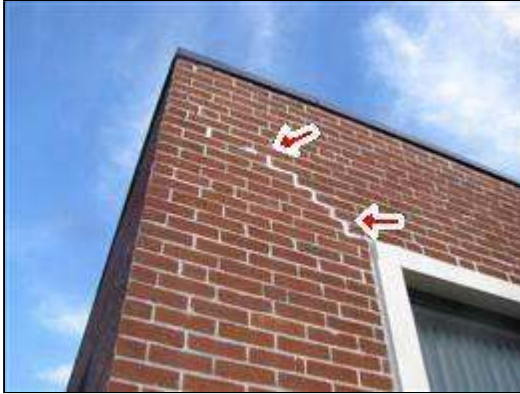
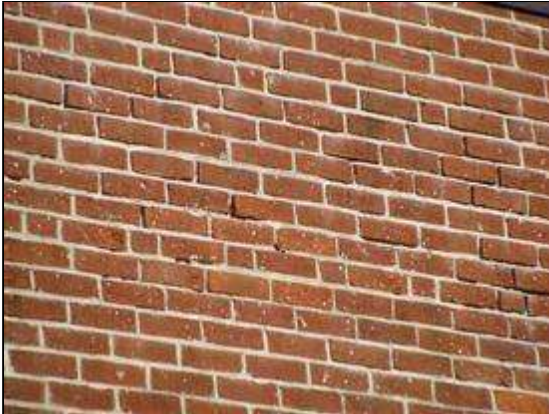
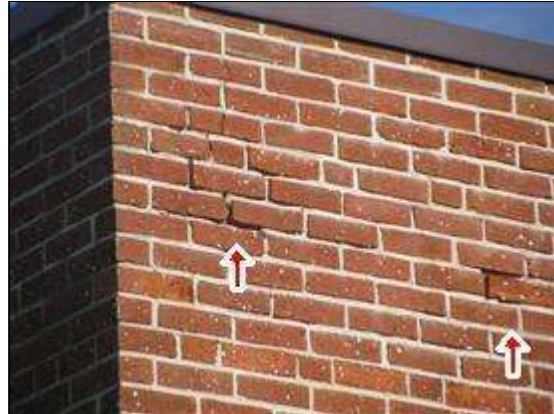
(1) Step cracks and spalling of the brick noted at north west side of building.

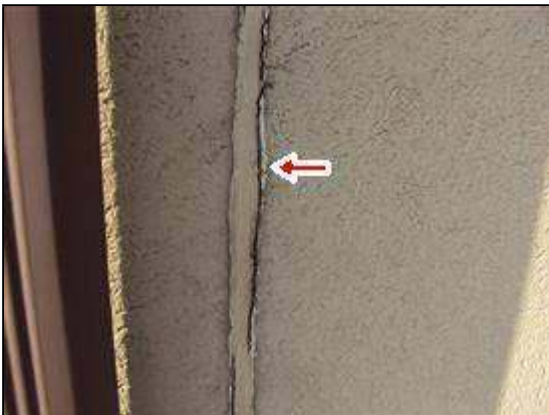
(2) Separation at wall joint, numerous exterior cracks, water infiltration point and potential structural issue when combined with the cracks and differential settlement noted at the interior of the exterior walls and piers. Further evaluation by a structural engineer is recommended.

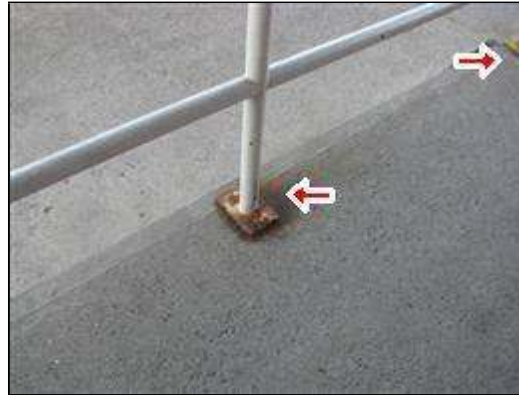
(1) Rusty feet on handrail for exterior building ramp - budget for replacement. Rails are still functioning as designed.

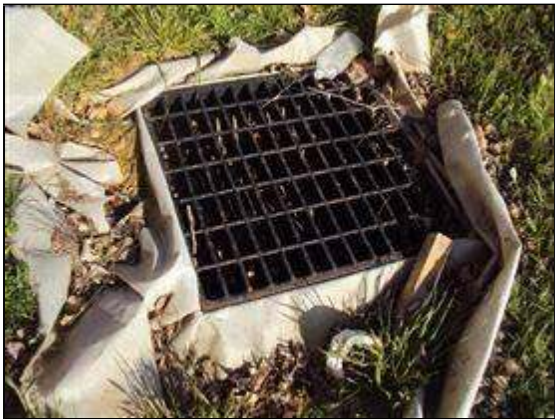
(3) Debris around drainage grate.

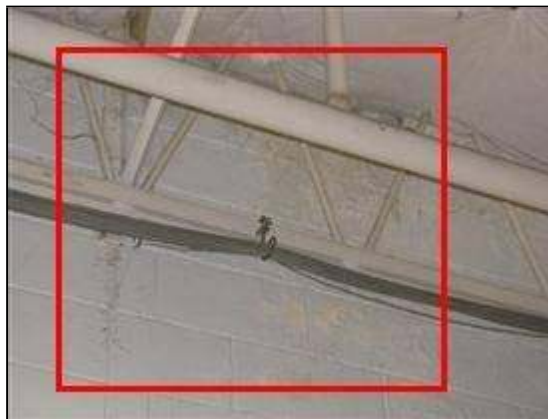
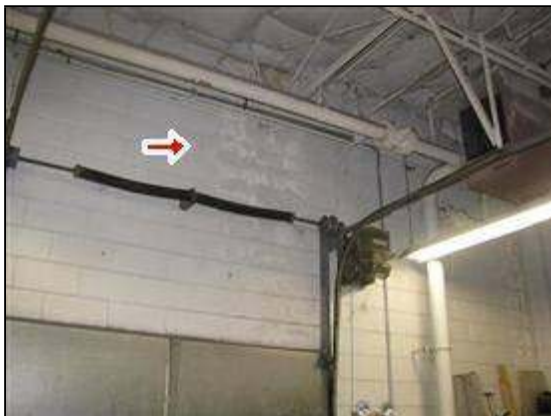
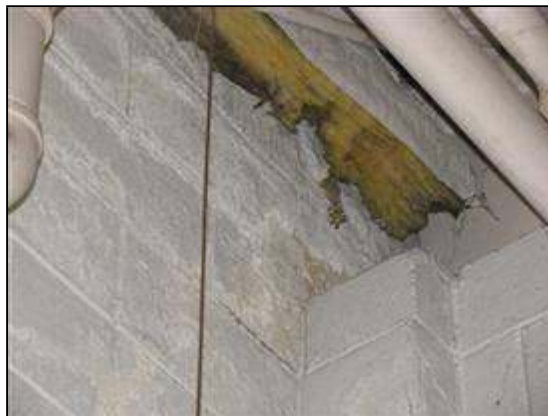
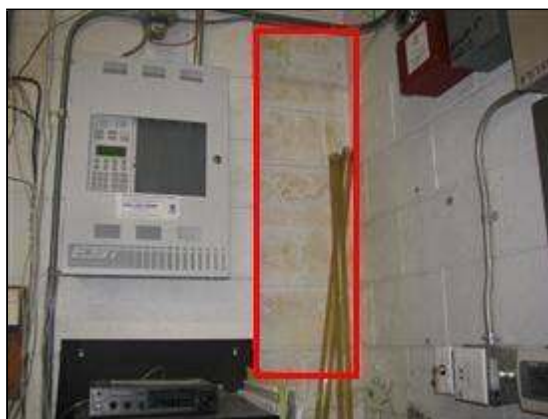
Efflorescence due to water infiltration through block, brick walls was noted along the north wall in warehouse & packing areas and along north wall of conference room north west office due to deteriorated gutter system and poor grading at the north east side of the building.

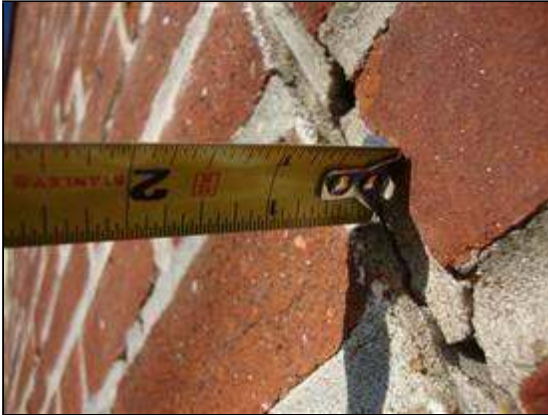
West exterior wall differential settlement, spalling noted. Improper grading allowing water to flow toward the building and undermine the foundation at the south west corner of the building. A landscaping professional, foundation contractor and or a mason should be consulted to improve grading and drainage as well as to make appropriate repairs.

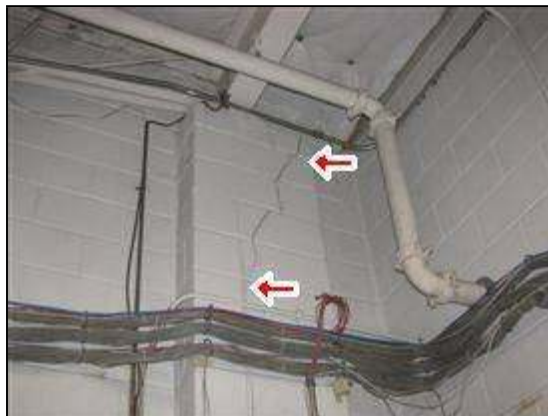
Block pier at south west corner of shipping/receiving (near electrical panels) is cracked and shows differential settlement and measured in excess of 5/8ths of an inch in width. A structural engineer should evaluate the extent of the settlement issues currently affecting the building at the north east as well as the south west sides.

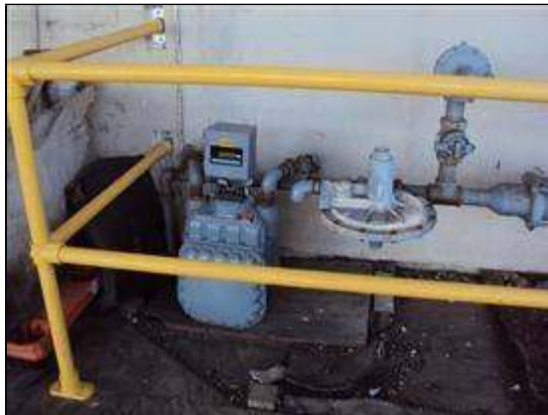
Shut off located at the gas main for warehouse/offices.

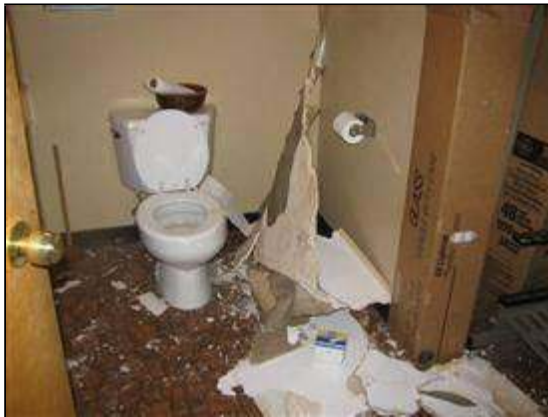
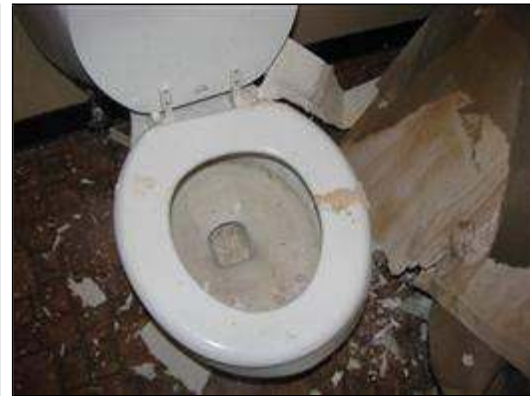
No water supply at time of inspection.

The bathroom is in a state of disrepair and should be gutted and rebuilt.

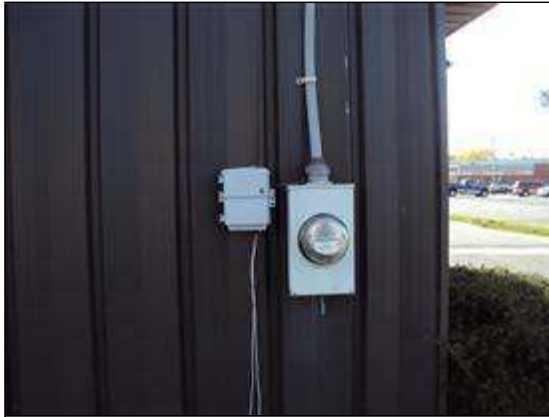
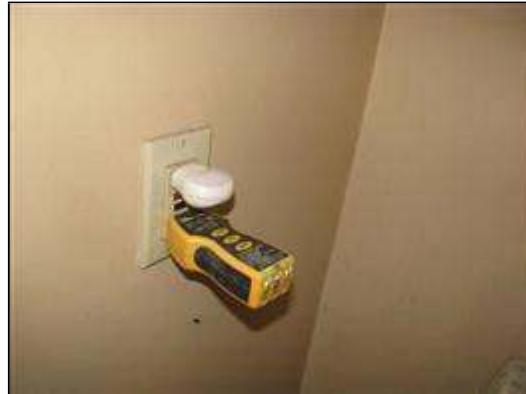
GFCI receptacle in bathroom does not trip and is in need of replacement.

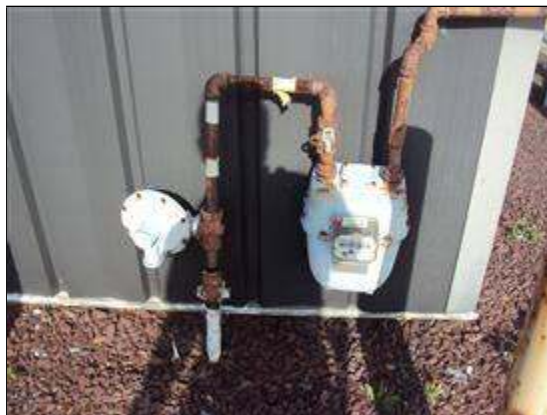
Gas meter at exterior of retail store.

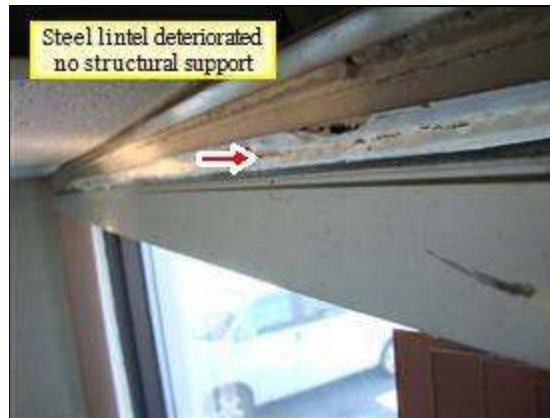
(1) Room 104A - North wall - West end of building - office area: Moisture intrusion from exterior block wall - paint delamination and rust from lintel over window. Right side of window has step cracks above ceiling with 1/4 inch differential settlement. Some degradation of concrete deck panels evident. The inspector utilized a Testo 881 thermal imager and Tramex moisture meter to confirm active water migration to the interior of the building.

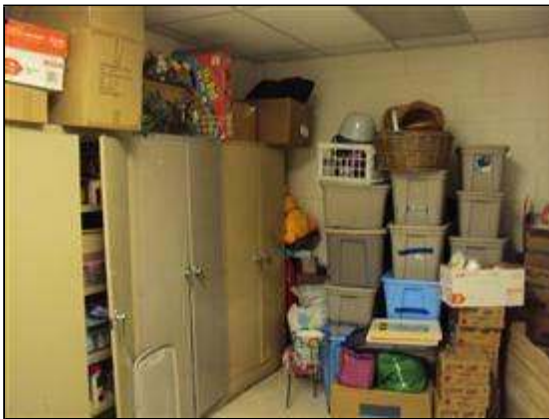
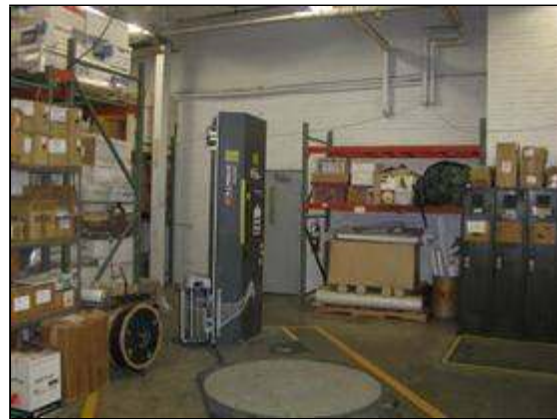
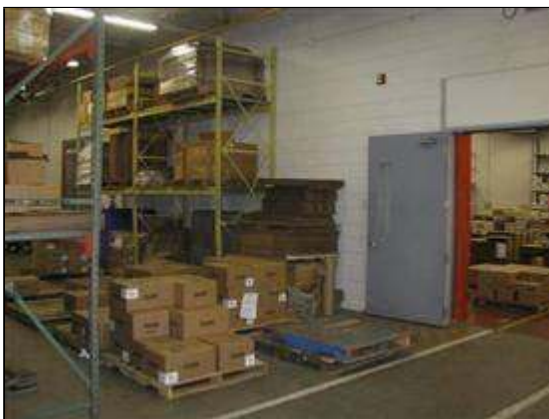
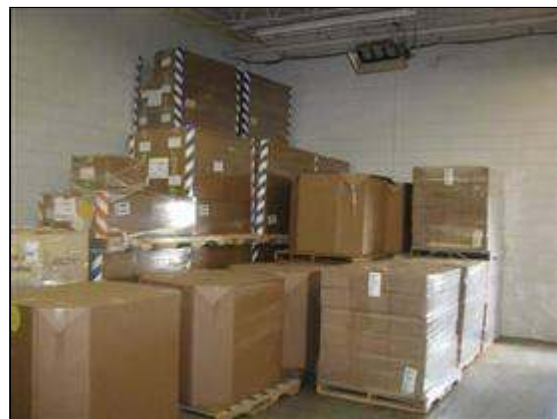
(2) Numerous storage areas prevented visual inspection of floors walls and ceilings. Photos are a representative sample of these areas.

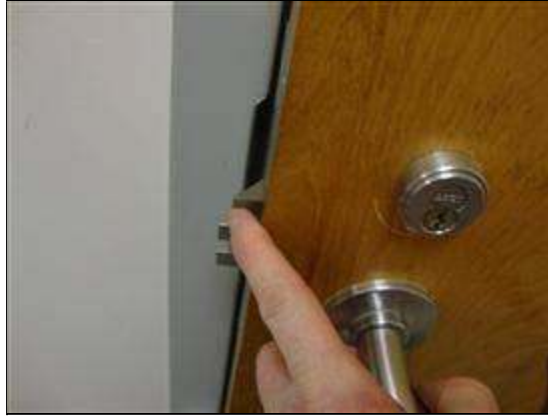
Machine shop - door does not fully latch from training room to machine shop.

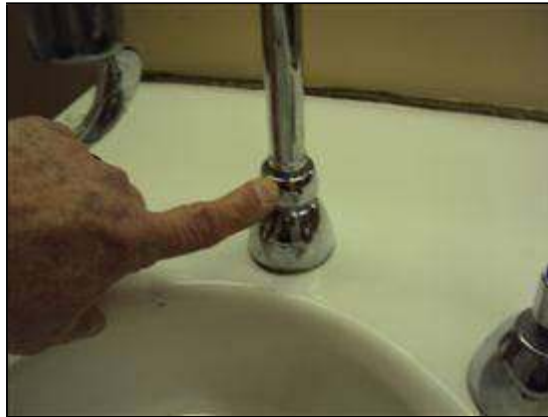
Room 107 - Assembly area men's room - Loose sink spout on center sink - slow drain at right sink.

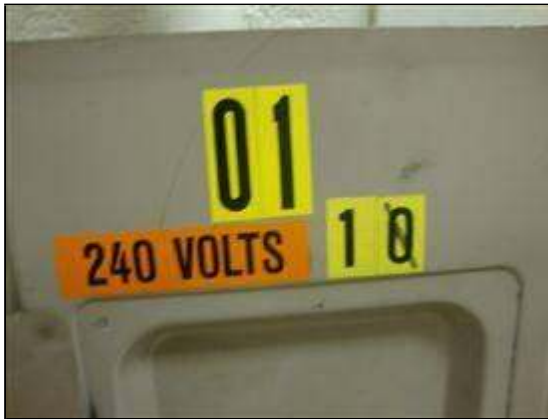
Improper screw used to secure the panel cover (dead front).

The majority of the electrical panels have improper screws that need to be replaced with panel box cover screws that have blunt ends so they do not pierce the wires inside the box.

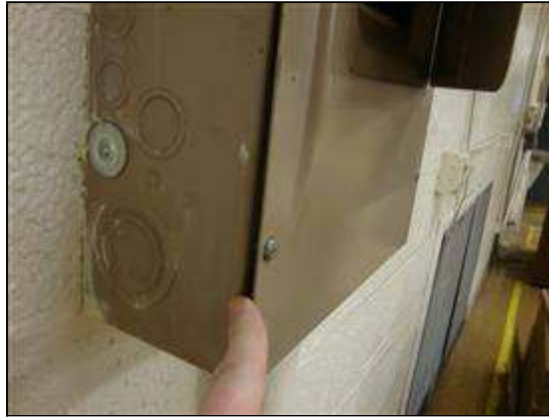
(4) Electrical panel #3 - 240V three phase - Improper sharp screws installed, screws are stripped and can not secure the panel cover.

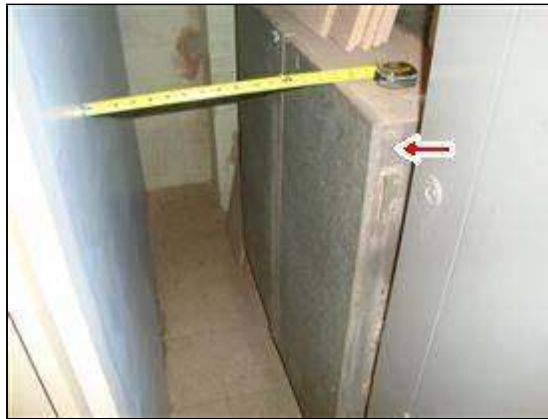
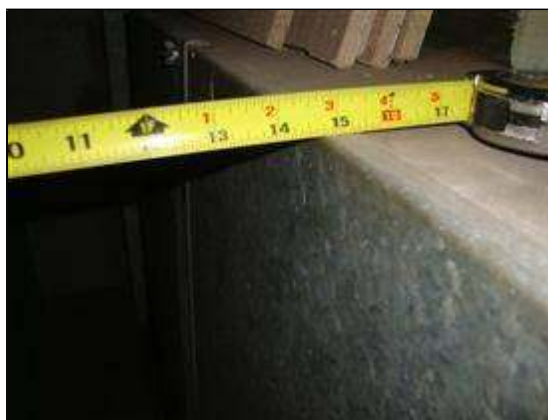
(6) Electrical splice box does not have proper work space - less than 3 ft. egress.

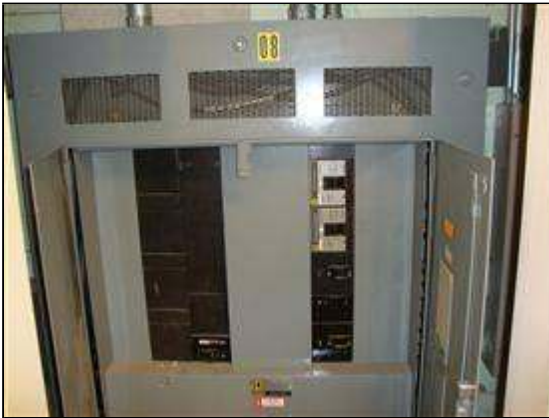
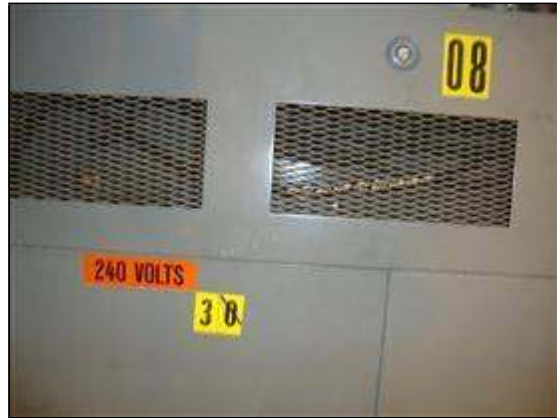
(7) Electrical panel #8 - 240V three phase - PPE (personal safety equipment) and a licensed electrician needed to access safely.

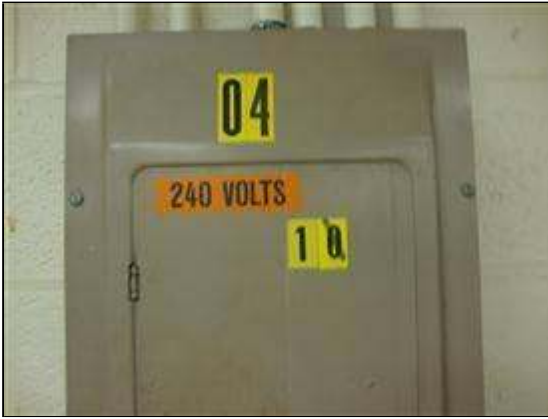
(9) Electrical panel #4 - 240V single phase - double tap wires.

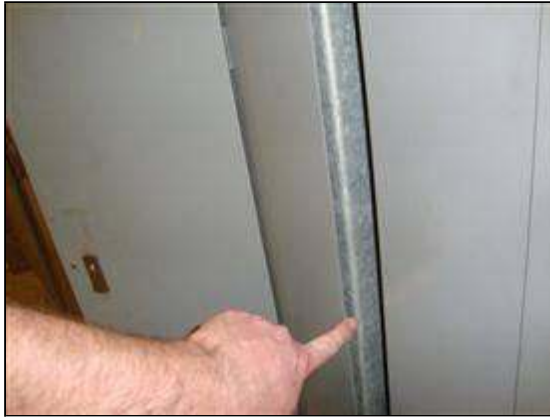
(10) Electrical panel #11 - 240V single phase - locked, missing screws, dead front not firmly affixed.

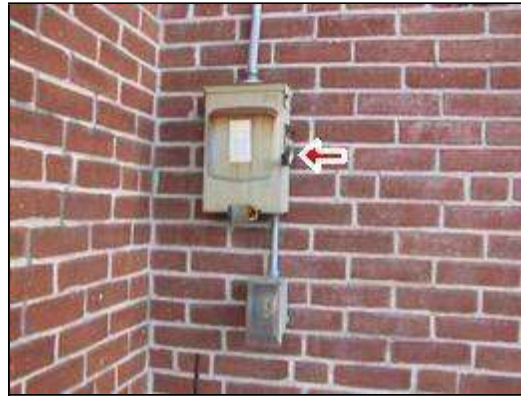
(1) Service switch supplying exterior receptacle should have a lock installed to help prevent tampering and potential shock hazards.

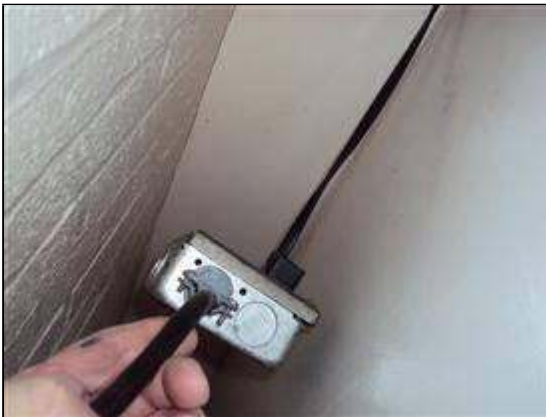
(2) 4x4 electrical junction box not firmly affixed to the structure.

Receptacles were not functional at the time of inspection.

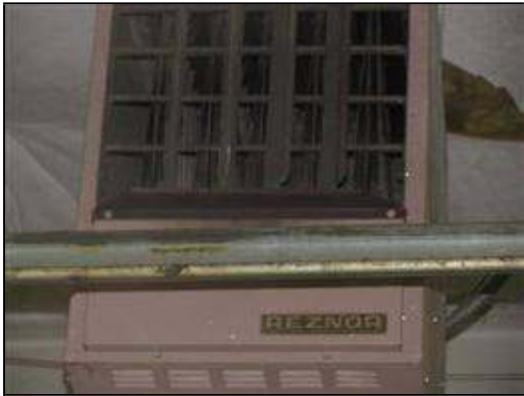
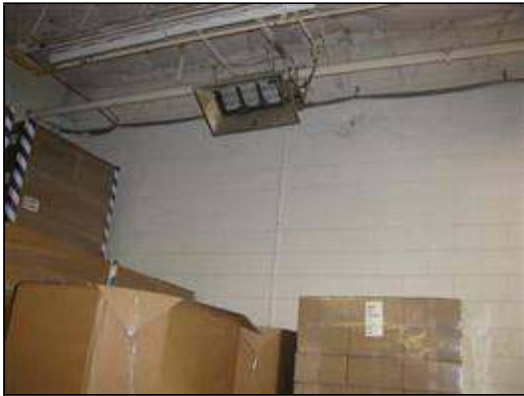
(1) Some of the heating units in the warehouse were not functional or could not be tested due to inaccessible thermostats.

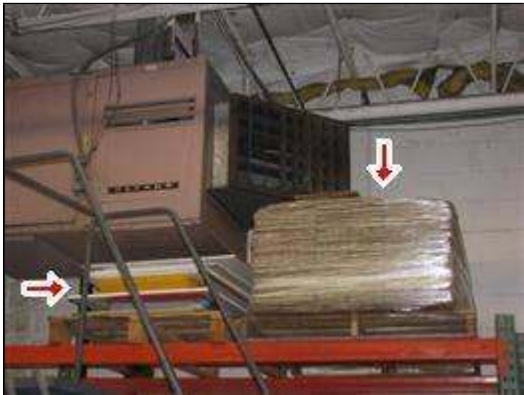
(2) Combustible materials in close proximity to heating unit - this unit was not tested due to potential fire hazard.

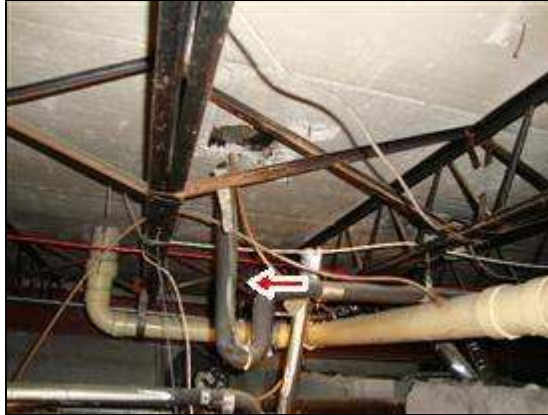
- (3) The offices are served with forced hot air by a boiler connected to a series of hot water coils installed inside the ductwork.

Digital photo depicts an example of hot water coils - no issues noted with this system.
